Gilson BROTHERS COMPANY

Service Bulletin #67

Subject: Snowthrower chute pop rivet replacement kit #27883 for 1973 models 5 thru 8 HP friction drive units.

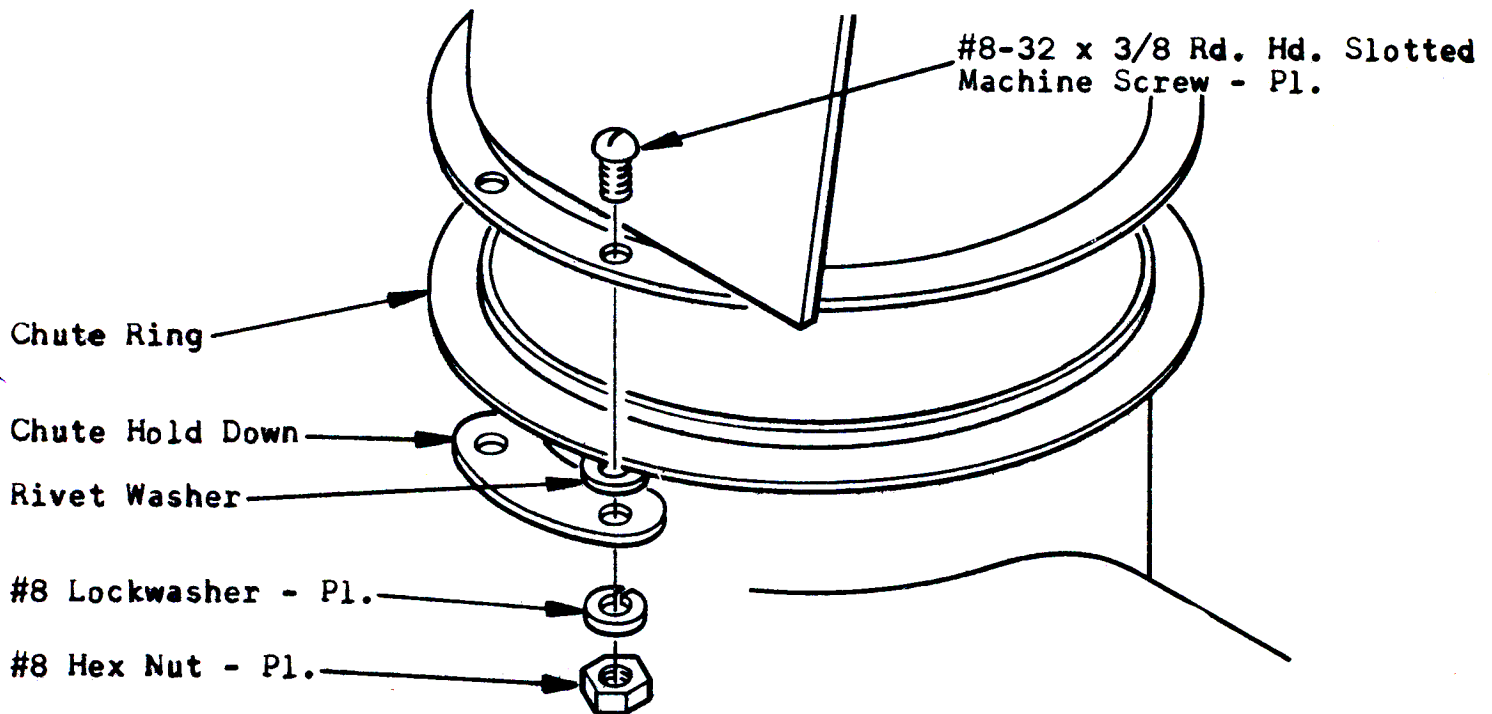
Aluminum-pop rivets failures on the snowthrower chute and gear assembly have been reported. This problem can be corrected by ordering number 27883 field kit, or if hold down clips are not lost, replace rivet with standard hardware listed below. The complete repair is approximately a 15 minute job and may be handled under warranty. File one claim for all repairs, but list individual unit serial numbers. The repair is simple, using common tools; many of your customers could handle this repair themselves. This would expedite time and eliminate the inconvenience of bringing the unit into your shop.

Replace all 6 pop rivets in the following manner. To remove rivets from chute assembly, use a 5/32 drill to drill out rivets or chisel heads of pop rivets off. Insert #8-32 x 3/8 Rd. Hd. Machine Screw through top of holes in chute assembly. Attach 24284 chute hold down and fasten with spring lockwasher and tighten nut securely.

If the chute binds when screws are tightened, remove one chute hold down and insert two rivet washers between chute hold down and chute ring. Repeat this operation with the other chute hold downs until chute moves freely.
