Gilson BROTHERS COMPANY

Service Bulletin #85

SUBJECT: Gear Drive Snowthrowers Belt, Pulley, Chute Collar Idler Bracket Roll Pin, Wheel and Tire Corrections. Models 55012 - 55012A - 55017

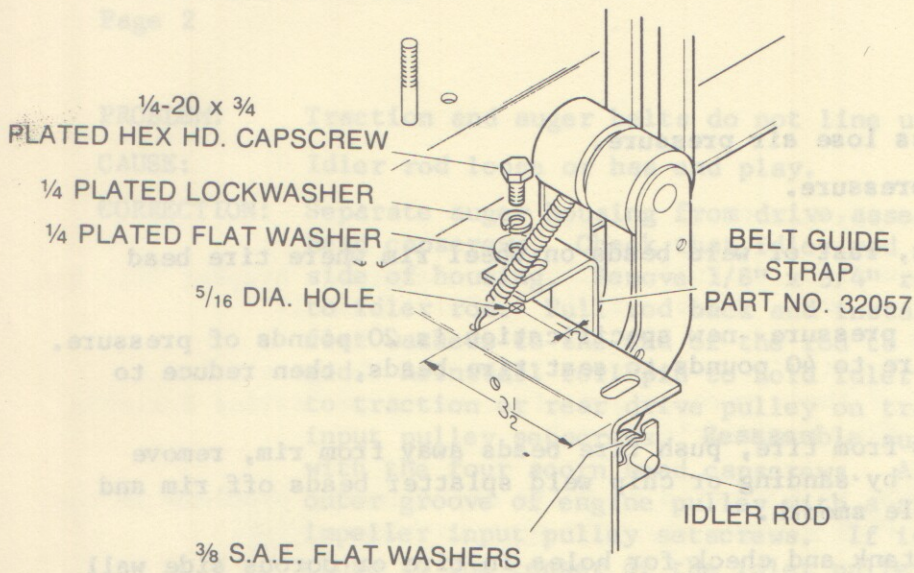
FIG. 1

PROBLEM: Traction belt jumps off pulley or rolls over.

CAUSE: Idler pulley does not hold enough tension onto belt when snowthrower hits solid object like ice, solid frozen snow, or raised portion or uneven sidewalk.

CORRECTION: Install new belt guide stop #32057 to hold belt in pulley when shock load experienced.

1. Drill 5/16" hole in frame 1/2" from inside edge and 3 1/2" back from front edge of idler slot.
2. Engage traction clutch lever.
3. Attach belt guide strap--within 1/16" of belt and pulley--be sure guide is square with belt and belt is engaged. (See Fig. 1.)

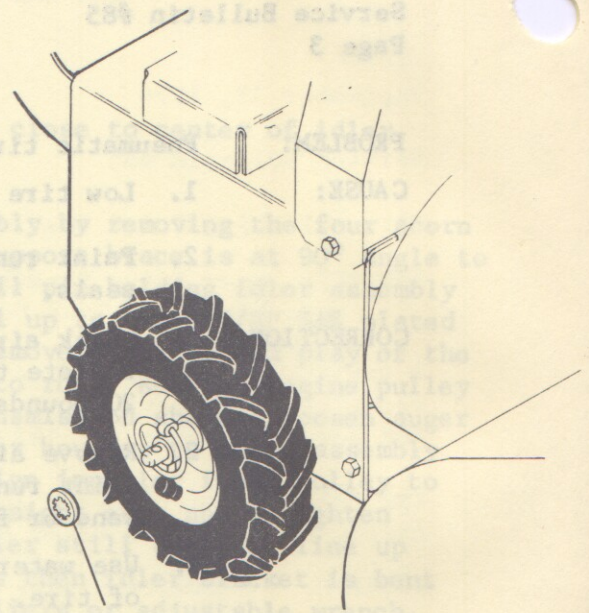
FIG. 2

PROBLEM: Traction belt chewed up from chain riding belt.

- CAUSE:
1. Cotter pin on chain connecting link incorrectly positioned on belt side--remove cotter pin and connecting link reposition so cotter pin on frame side of chain.
 2. Wheels and klik pins incorrectly positioned in outer axle shaft hole for traction drive. As outlined in Owner's Manual and Service Bulletin #68 dated 12-28-72, wheels should drive in inner hole as outside hole is for free wheeling only.

CORRECTION: Install klik pins through wheel hole and inside hole of axle shaft; then push new retainer ring #32224 onto axle shaft until it is tight against wheel hub. This will prevent wheel from being pulled to outside hole for incorrect position for driving unit and causing premature belt failure. (See Fig. 2)

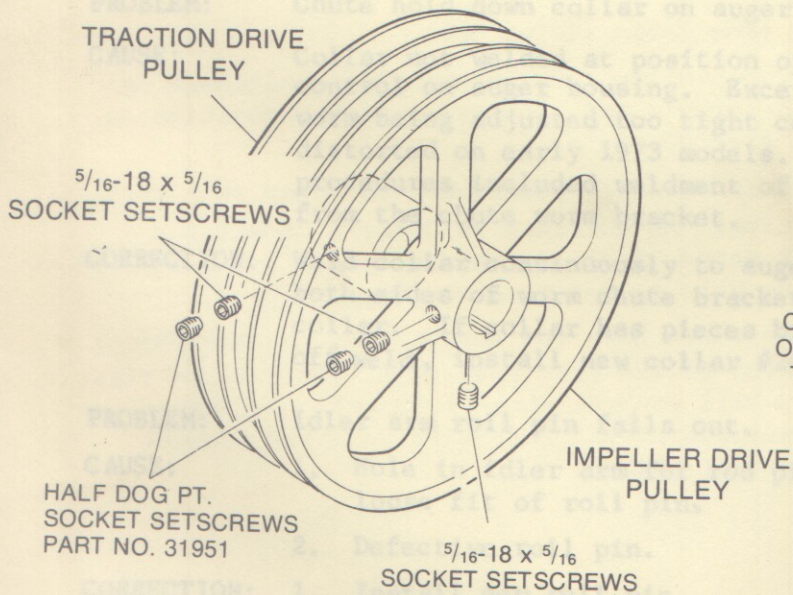
FIG. 3

PROBLEM: Traction and impeller--pulley setscrews loosen up.

CAUSE: Setscrews not torqued tight enough or shock loads.

CORRECTION: Tighten setscrews to 140 inch pounds of torque and install a second or locking half dog point setscrew part #31951 in hole located 90° to keyway. A second setscrew can not be installed in keyway setscrew hole due to the thinner portions of the hub for the keyway. (See Fig. 3.)

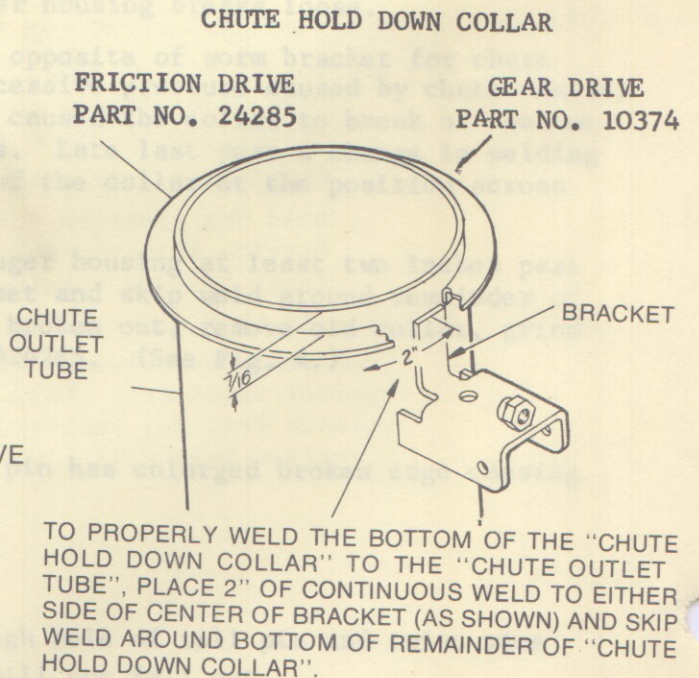
FIG. 4

PROBLEM: Chute hold down collar on auger housing breaks loose.

CAUSE: Collar not welded at position opposite of worm bracket for chute control on auger housing. Excessive pressure caused by chute control worm being adjusted too tight caused the collar to break or become distorted on early 1973 models. Late last year a change in welding procedures included weldment of the collar at the position across from the chute worm bracket.

CORRECTION: Weld collar continuously to auger housing at least two inches past both sides of worm chute bracket and skip weld around remainder of collar. If collar has pieces broken out, remove old collar, grind off weld, install new collar #24285. (See Fig. 4.)
