Gilson BROTHERS COMPANY

SERVICE BULLETIN # 100

SUBJECT: Gear Drive Snowthrower axle shaft bushing

MODEL #'S INCLUDED: 55062, 55063, 55063A, 55017, 55012, 55012A

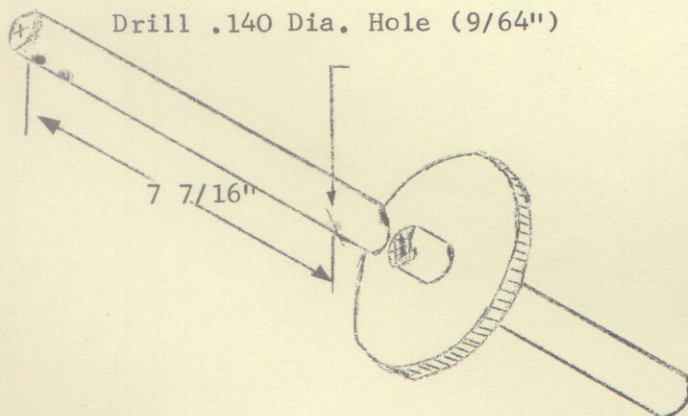
FIG. 1

The occurrence of the inside left hand axle shaft bearing being pushed out of the bearing, when lubricating with a high pressure grease gun, has been brought to our attention.

The solution to this problem is to drill a hole .140 inch ($9/64$ ") in diameter in the axle shaft at a location of $7 \frac{7}{16}$ inches from the left hand outer edge of the axle shaft. (Fig. 1) Insert a $1/8$ " x $1 \frac{1}{4}$ " cotter pin and bend the ends over to hold the bushing in place.

Drill $9/64$ " Hole
