Gilson BROTHERS COMPANY

Service Bulletin #108

Subject: Wearing of recoil starter rope on Air Duct - Blower Housing (37947)

Models: #55091, 35210A, 55098 and GIS 7510A87 Compact Snowthrowers

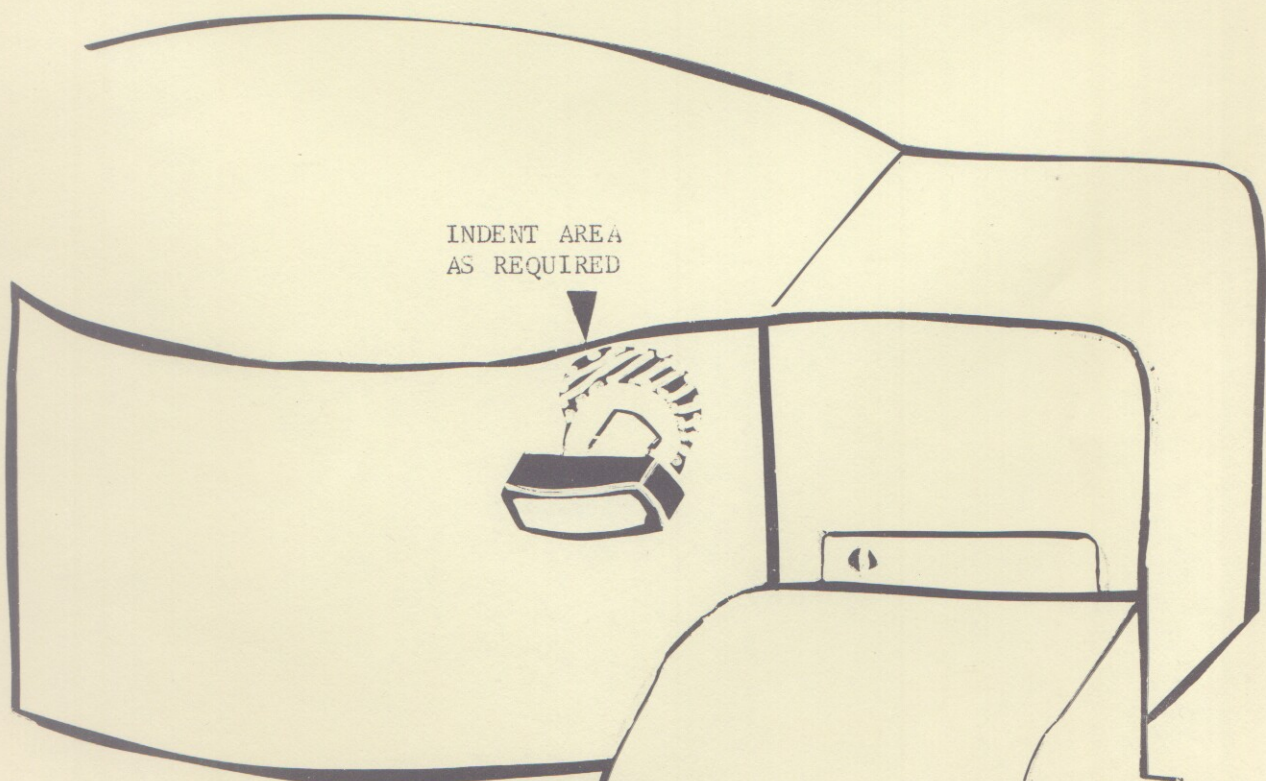
It has been brought to our attention that chaffing and failure of the recoil rope has been experienced on some of the above models. This is caused, by the recoil rope rubbing the edge of the cut out in the #37947 Air Duct when pulling the rope vertically.

Correction of this condition is achieved, by merely indenting the area above the recoil outlet slightly with a ball-peen hammer, so the rope will clear. Fig. 1 illustrates the area which should be indented for clearance.
