Gilson BROTHERS COMPANY

Service Bulletin #120

Subject: Snow Blow-By At Deflector When In Side Discharge Position On 2HP Snowthrower

Models: 1850 - 55129 - 55130 - 55179 - 35250 - GIS7504A97 - 09GN5139 - 09GN5140

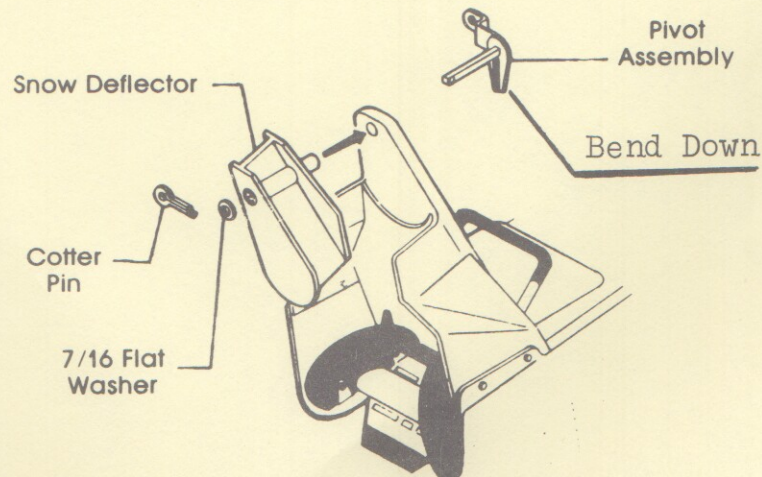
Reports have been received that a small amount of snow blows out between the auger housing and the side of the deflector in light loose snow.

Investigation showed that most of the snow is blowing out between the top of the deflector and the top leading extension of the deflector support.

To reduce blow-by, remove deflector pivot assembly, and bend the top rear detent section of pivot assembly down slightly. Remount pivot assembly and deflector. Clamp deflector tight to top extension housing using two "C" clamps or two vise grips, one on each side of center vane of deflector. Reinstall flat washers removed and add sufficient 7/16" thin washers to take out play between deflector and cotter pin. Install cotter pin, release "C" clamps or vise grips.
