# Gilson®

Service Bulletin #204

SUBJECT: Lower Shift Rod Freeze-Up on Snowthrowers

Units Involved: All 5, 8 & 10 HP 5-Speed Snowthrowers produced prior to the 1984-85 season incorporating the sliding shift rod design (Fig. 1 & 2) identified also by S.N.'s lower than 3313C1001 and Date Code 3L12C11 for Ford Units.

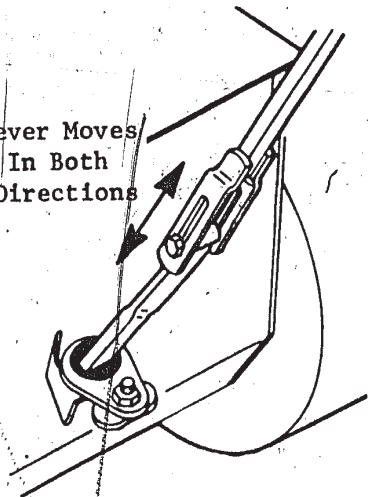
FIG. 1

We have received reports from the field advising that the lower shift rod freezes or hangs up in the bottom bushing and shifter bellcrank through which it passes. On the subject units, minimal frictional contact in these areas is beneficial for ease of operation.

Lever Moves  
 In Both  
 Directions

We are making available new lower shift rods for the subject units which contain milled slots on all four sides. Should a problem be encountered in which the problem described occurs, the following interchange list will assist you in obtaining the correct new style lever that may be installed:

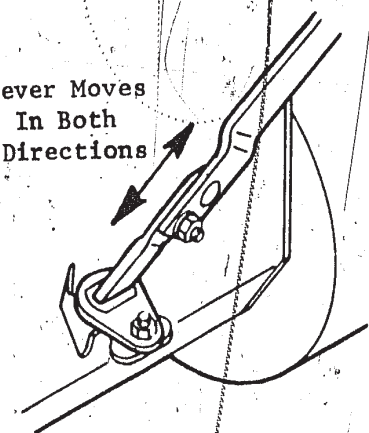
FIG. 2

Lever Moves  
 In Both  
 Directions
