Gilson BROTHERS COMPANY

Service Bulletin #85

SUBJECT: Gear Drive Snowthrowers Belt, Pulley, Chute Collar Idler Bracket Roll Pin, Wheel and Tire Corrections. Models 55012 - 55012A - 55017

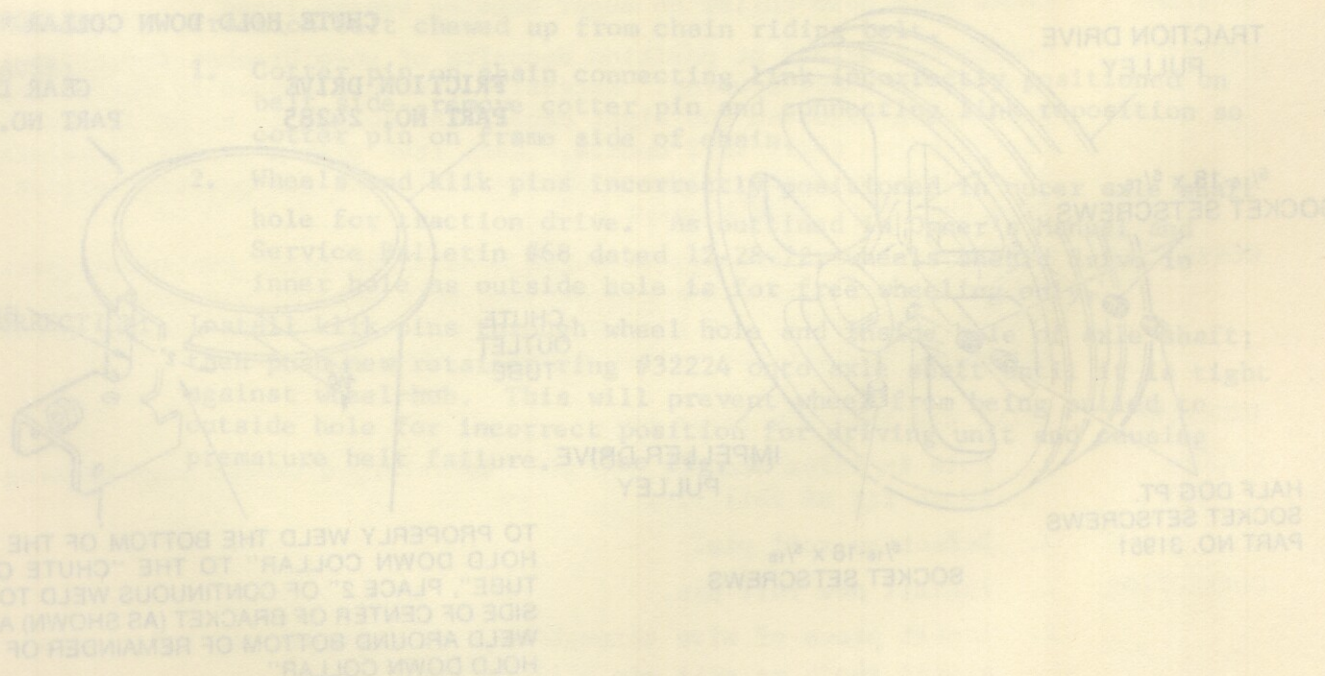
FIG. 1

PROBLEM: Traction belt jumps off pulley or rolls over.

CAUSE: Idler pulley does not hold enough tension onto belt when snowthrower hits solid object like ice, solid frozen snow, or raised portion or uneven sidewalk.

CORRECTION: Install new belt guide stop #32057 to hold belt in pulley when shock load experienced.

1. Drill 5/16" hole in frame 1/2" from inside edge and 3 1/2" back from front edge of idler slot.
2. Engage traction clutch lever.
3. Attach belt guide strap--within 1/16" of belt and pulley--be sure guide is square with belt and belt is engaged. (See Fig. 1.)
