Service Bulletin # GSBS-06

Subject: Wheel Seizure Prevention

Machine Style: All Self Propelled Units Where Wheels are Secured with Clevis or Click-Pins

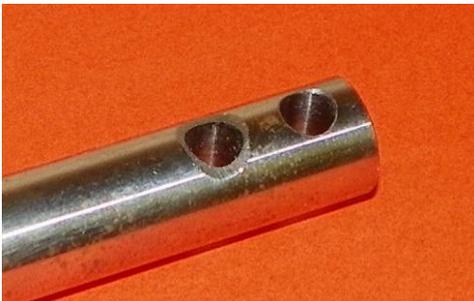
1. Remove the wheels
2. Clean the axles with solvent, WD-40 or anything that will remove old oil and gunk
3. Inspect the holes that pins the wheels when in use. Look for a shiny high spot at the edge of the hole where interference is beginning to develop.
4. Inspect the holes for some remaining relief. There was a factory countersink but it may be filled with deformation. Using a half-round or rat tail file add relief as shown in the following photo.

1. Coat the axle with SAE 30 oil and spin the wheel onto the axle for an even coating.
2. Replace pins.
