Service Bulletin # GSBS-09

Subject: Foote #1543 Bevel Gears in Model 35 reversing Transmissions

Machine Style: Early Gear Drive, 1 and 2 speed models with Foote Transmissions

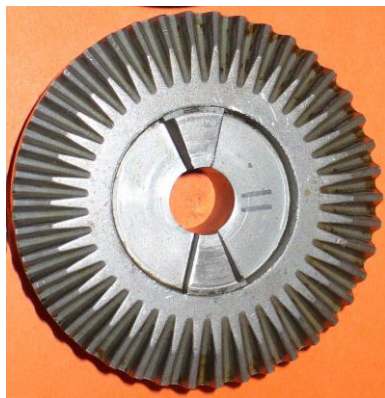
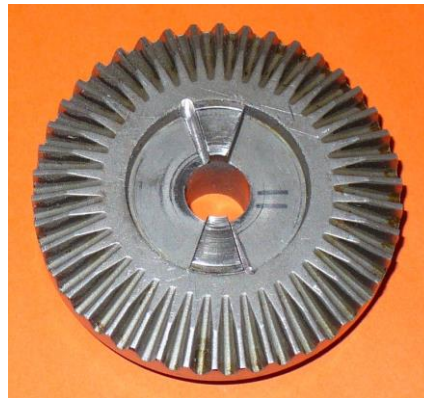
These transmissions include 2 bevel gears with recessed pockets & shoulders that allow a clutch collar to engage. Years of use, shifting fork wear, poor shifting technique and grease breakdown can contribute to rounding of these shoulders. When rounding is severe enough the transmission will begin to slip, skip or not engage at all.

These gears have been discontinued for many years. New old stock and good salvaged gears have become very scarce. If the shoulder wear is not excessive it is possible to machine the shoulders back to provide positive clutch collar engagement. If you bring your gears and clutch collar to a local machine shop they can understand the relationship and re-mate the gears and collar. Before and after photos are found below.

- Both gears operate in the same direction so it's not as simple as swapping them.
- The gears are hard; carbide tooling is required.
- The gears are sintered from powdered metal. I am not aware of any success in welding new material to these gears.
